RED RIVER WATERSHED

GILLHAM LAKE

COSSATOT RIVER, ARKANSAS

EMBANKMENT CRITERIA AND PERFORMANCE REPORT

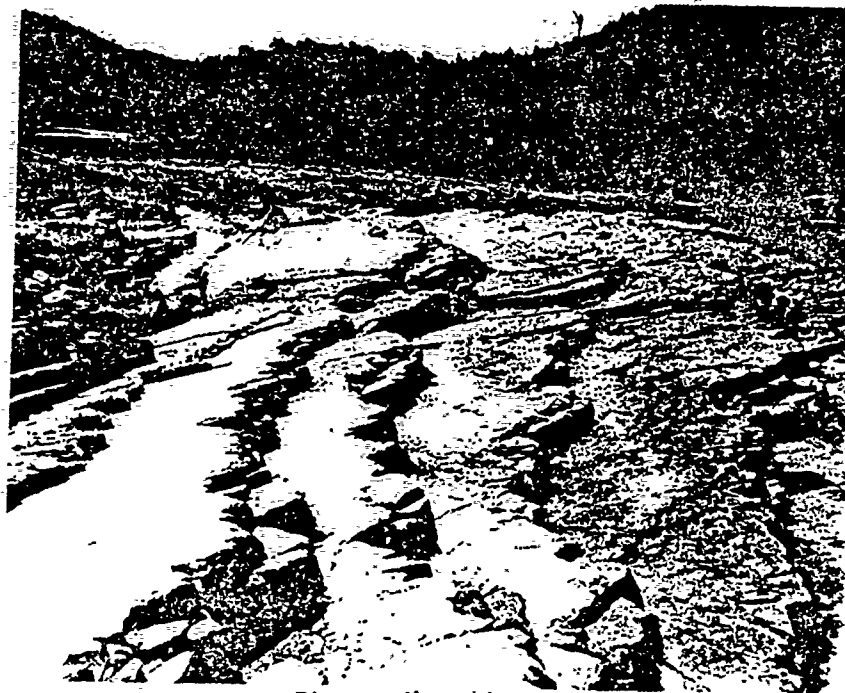
Photo. No. 11

Foundation under random and impervious zones from Sta 30+50 to 31+80 as seen from upstream toe of the random zone at Sta 31+80.

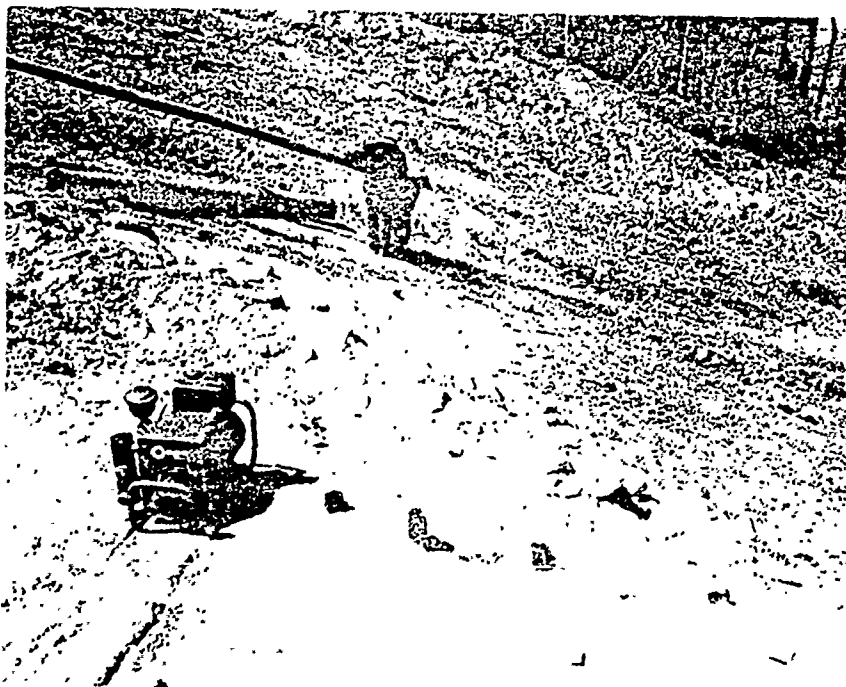
Photo. No. 22

View of grout holes U/S of C.C.T. at Sta 28+30 as seen looking U/S along strike of the fracture.
